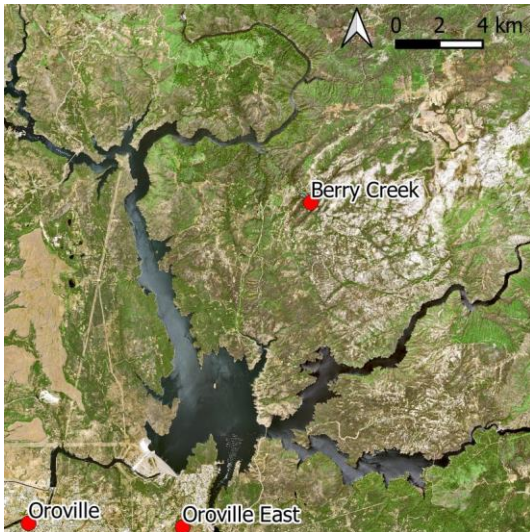
2023-05-19, Sentinel-2

Lake Oroville Reservoir, located in Northern California's foothills, spans approximately 62 square kilometres, and has a maximum capacity of around 4.3 cubic kilometres of water when filled to the brim. Satellite images offer a striking view of its vast expanse and intricate network of tributaries and allow for monitoring both its filling status and its water quality.

- Look at the satellite image from 2021. Which land cover classes can you identify? Look at the barren, grey area east of the lake. Can you imagine, why this region is not vegetated? (The area was affected by the North Complex Fire in 2020).
- Compare the satellite images from 2021 and 2023. Which changes in the landscape are most prominent?
- Focus on the water surfaces, which changes can you identify?
- Look at the layer “Waterbodies” derived from the satellite data and estimate the proportional change of the water surface.

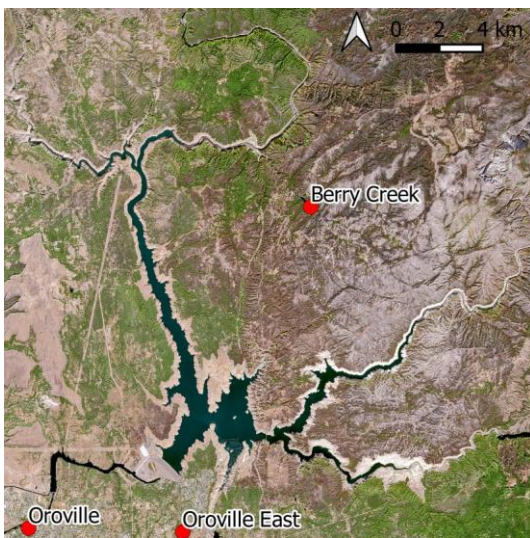
2021-10-16, Sentinel-2

However, climate change poses an increasing challenge. Rising temperatures and altered precipitation patterns have led to prolonged droughts, causing the reservoir's water levels to plummet. In recent years, Lake Oroville has experienced alarming drops, with water levels decreasing by up to 60 metres in some instances. In this context, spring 2023 was special as intense rainfall filled the reservoir, thus pausing the drought.

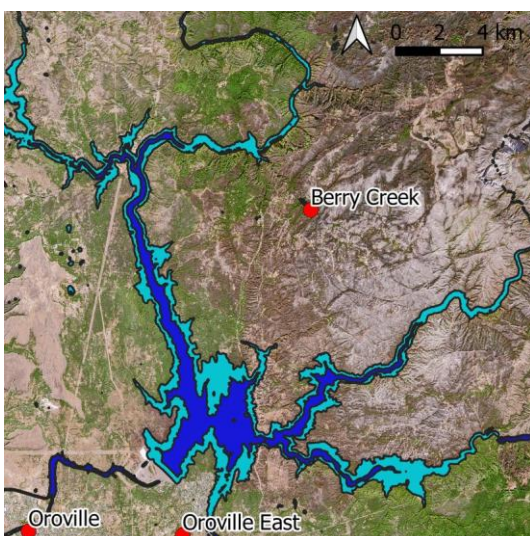
2021-10-16, Sentinel-2, water bodies derived from satellite images
