The Almendra Reservoir covers an area of more than 8,000 hectares, making it one of the largest reservoirs of Spain. It is located near the Spanish-Portuguese border in the region of Castilla y León and is a lifeline for the local agriculture sector. It was created between 1963 and 1970 with the construction of the Almendra Dam on the Tormes River. The dam provides water for two tasks: irrigation of agricultural land and producing energy in the Villarino hydropower station, which has an installed capacity of 810 Megawatts.

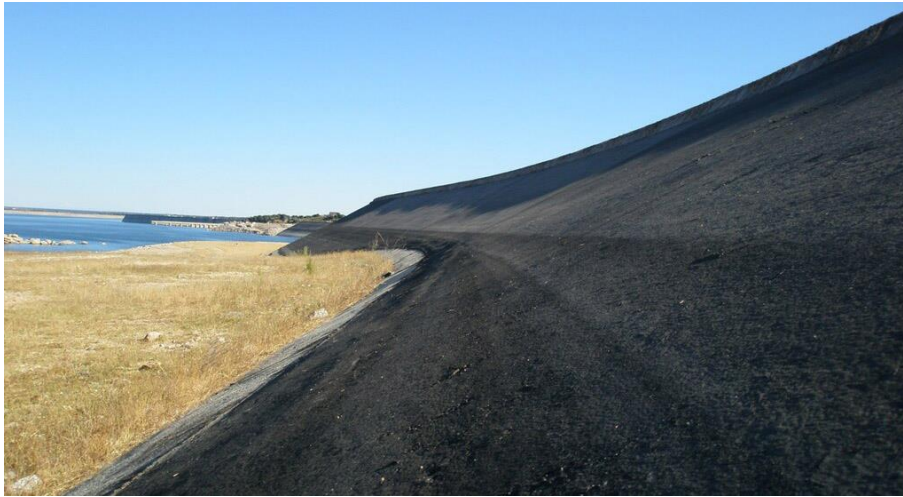
View of the dam showing the low water level (photograph: Perronaider)
