In September 2023, storm Daniel caused a severe flooding crisis in the region around Derna, a coastal city in Libya. Satellite images captured the extent of the disaster, showcasing large areas submerged under water, the change in the vegetation and the increased sediment load of the sea water after the event.

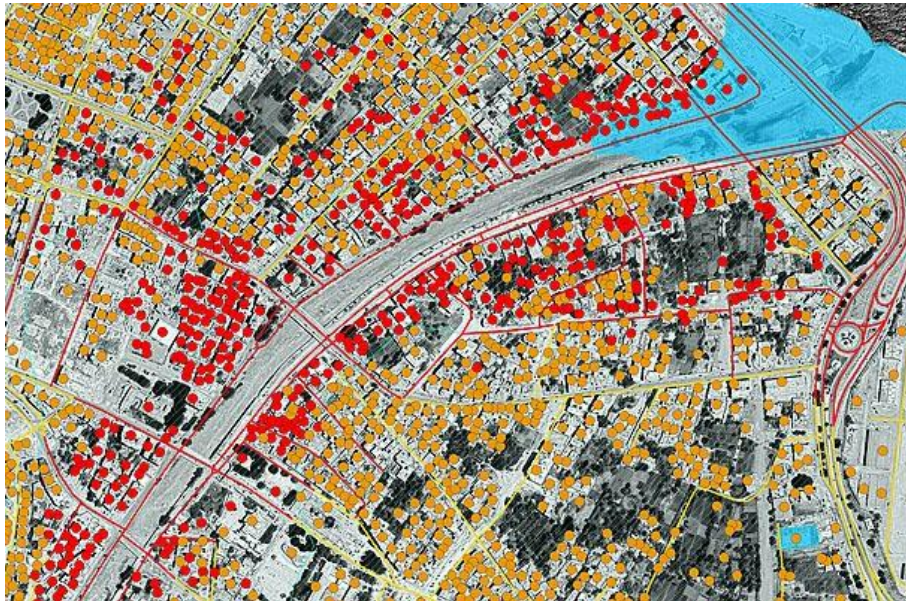
*Damage assessment map from the Copernicus Emergency Management Service
(red: objects destroyed by the flood, orange and yellow: damaged, blue: flooded)*

- Look at the satellite image from 2023-09-12 and compare it with the image acquired five days before on 2023-09-07, before the flood. Which changes can you detect?
- Due to the false-colour infrared visualization, the vegetation appears in red colour. Why do you think this makes sense here?
- Look at the town at the coast and try to identify the changes in detail (coastline, vegetation, roads near the coast, water).
- Compare your findings with the flood damage assessment map from the Copernicus Emergency Management Service provided below.
